SD/ND Conference March 2025

Accident Investigation
Division (AID)

Darren Lemmerman

Case Study
Atmos Energy
Dallas, Texas
Gas Migration
One Fatality and
Three Injuries
February 23, 2018

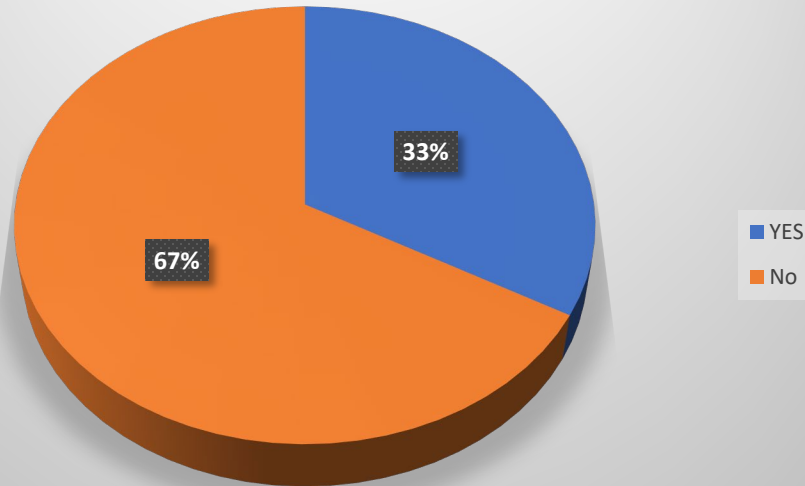
Was a CIS ever done on the HL pipeline rupture with external below grade corrosion failure?

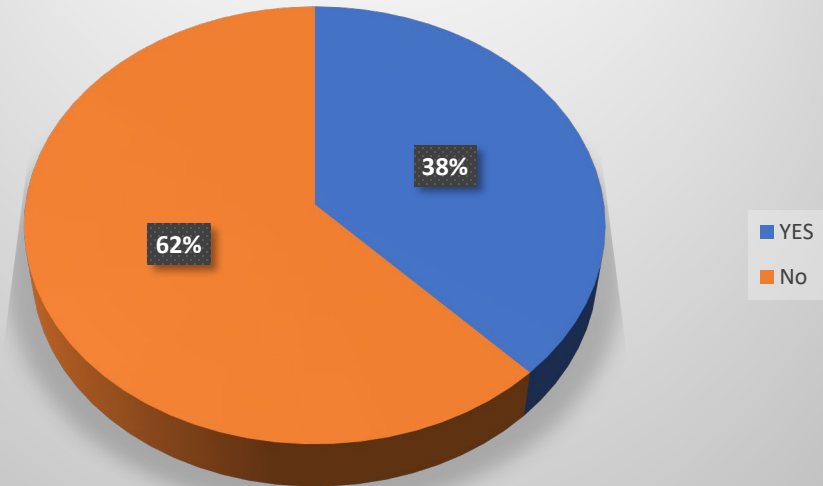
Was a CIS ever done on the GT pipeline rupture with external below grade corrosion failure?

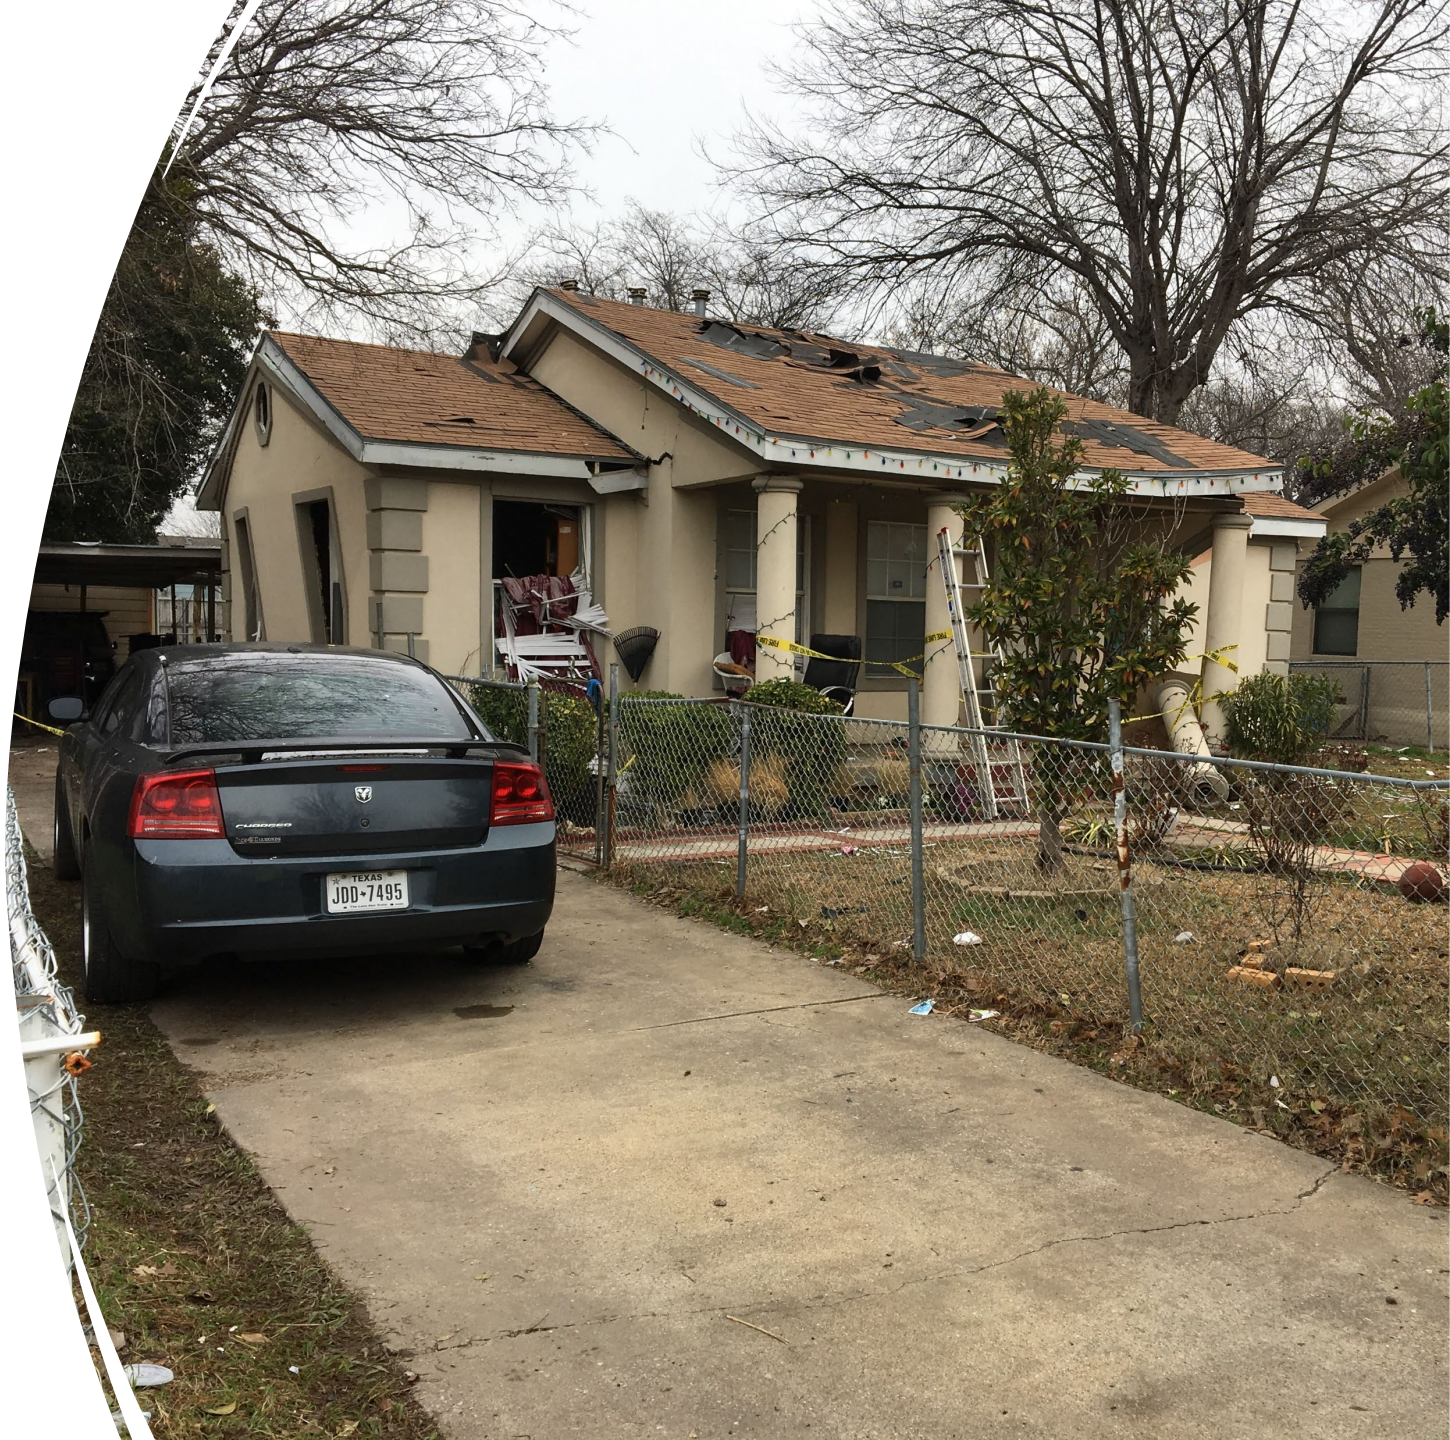
- February 21, 2018 – Day 1
- House 3527 has an incident at 5:49 a.m.
- Homeowner heard a popping noise in the attic where the heater unit is located. He investigated and found the steel cover to the furnace not on the unit.
- When the cover was reinstalled, the furnace operated the pilot-light igniter, and an explosion occurred throwing him backwards. He never smelled any gas odor.
- Arson investigators responded and determined the cause as “undetermined”.
- Gas company was also on site but not allowed to test service due to structure damage.
- Ground saturated from exceptionally heavy rains

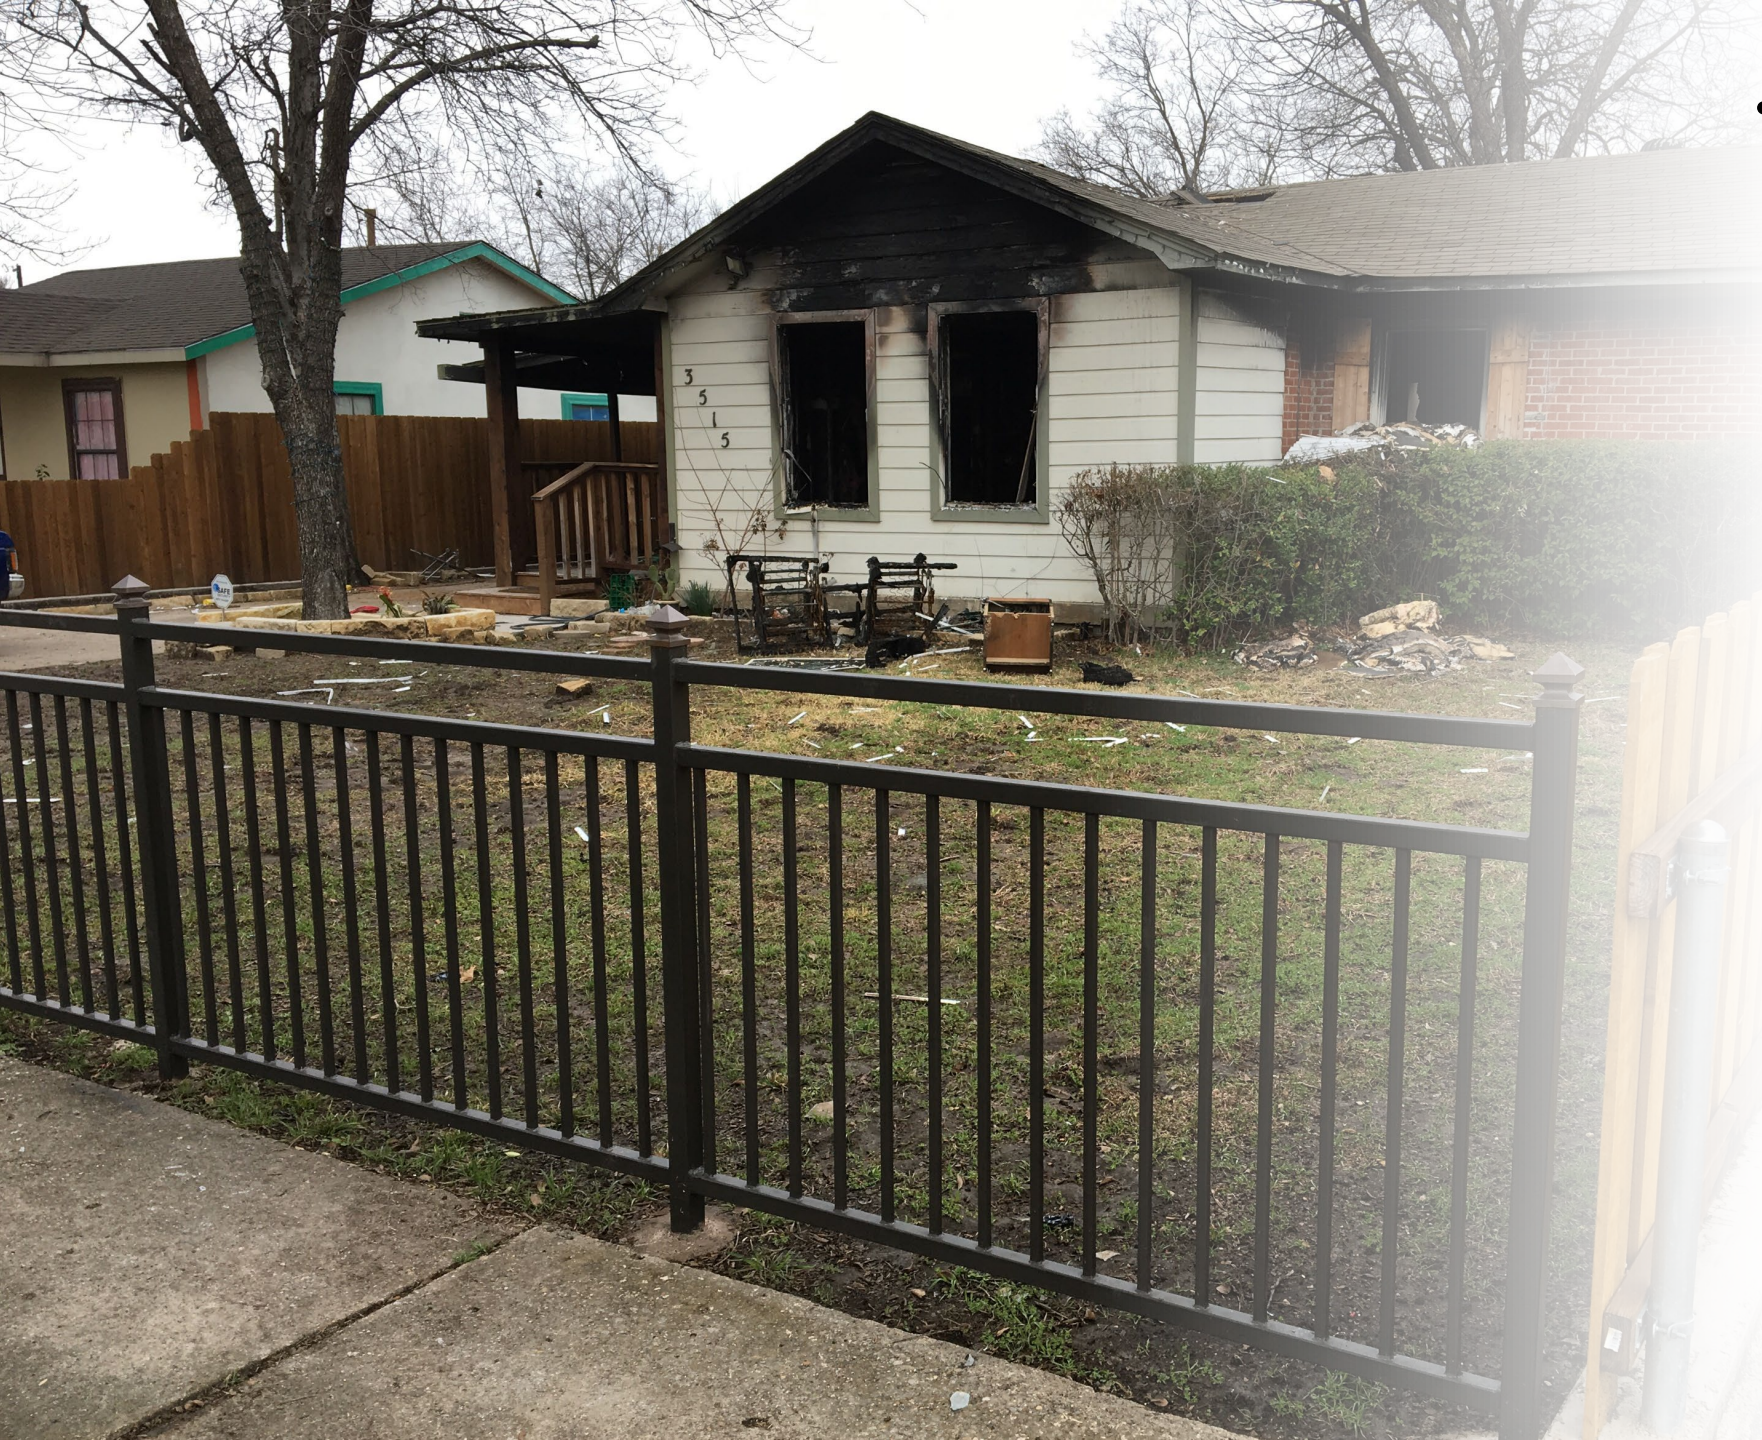
- February 22, 2018 – Day 2
- House 3515 has an incident at 10:21 a.m.
- Homeowner was alone and began to boil some water when the flames acted erratically and began to grow out of control and engulfed him.
- Fire traveled to attic causing additional damage.
- Arson investigators interviewed the witness and determined that it was an appliance issue.
- No gas odor detected by resident
- Rain continuing

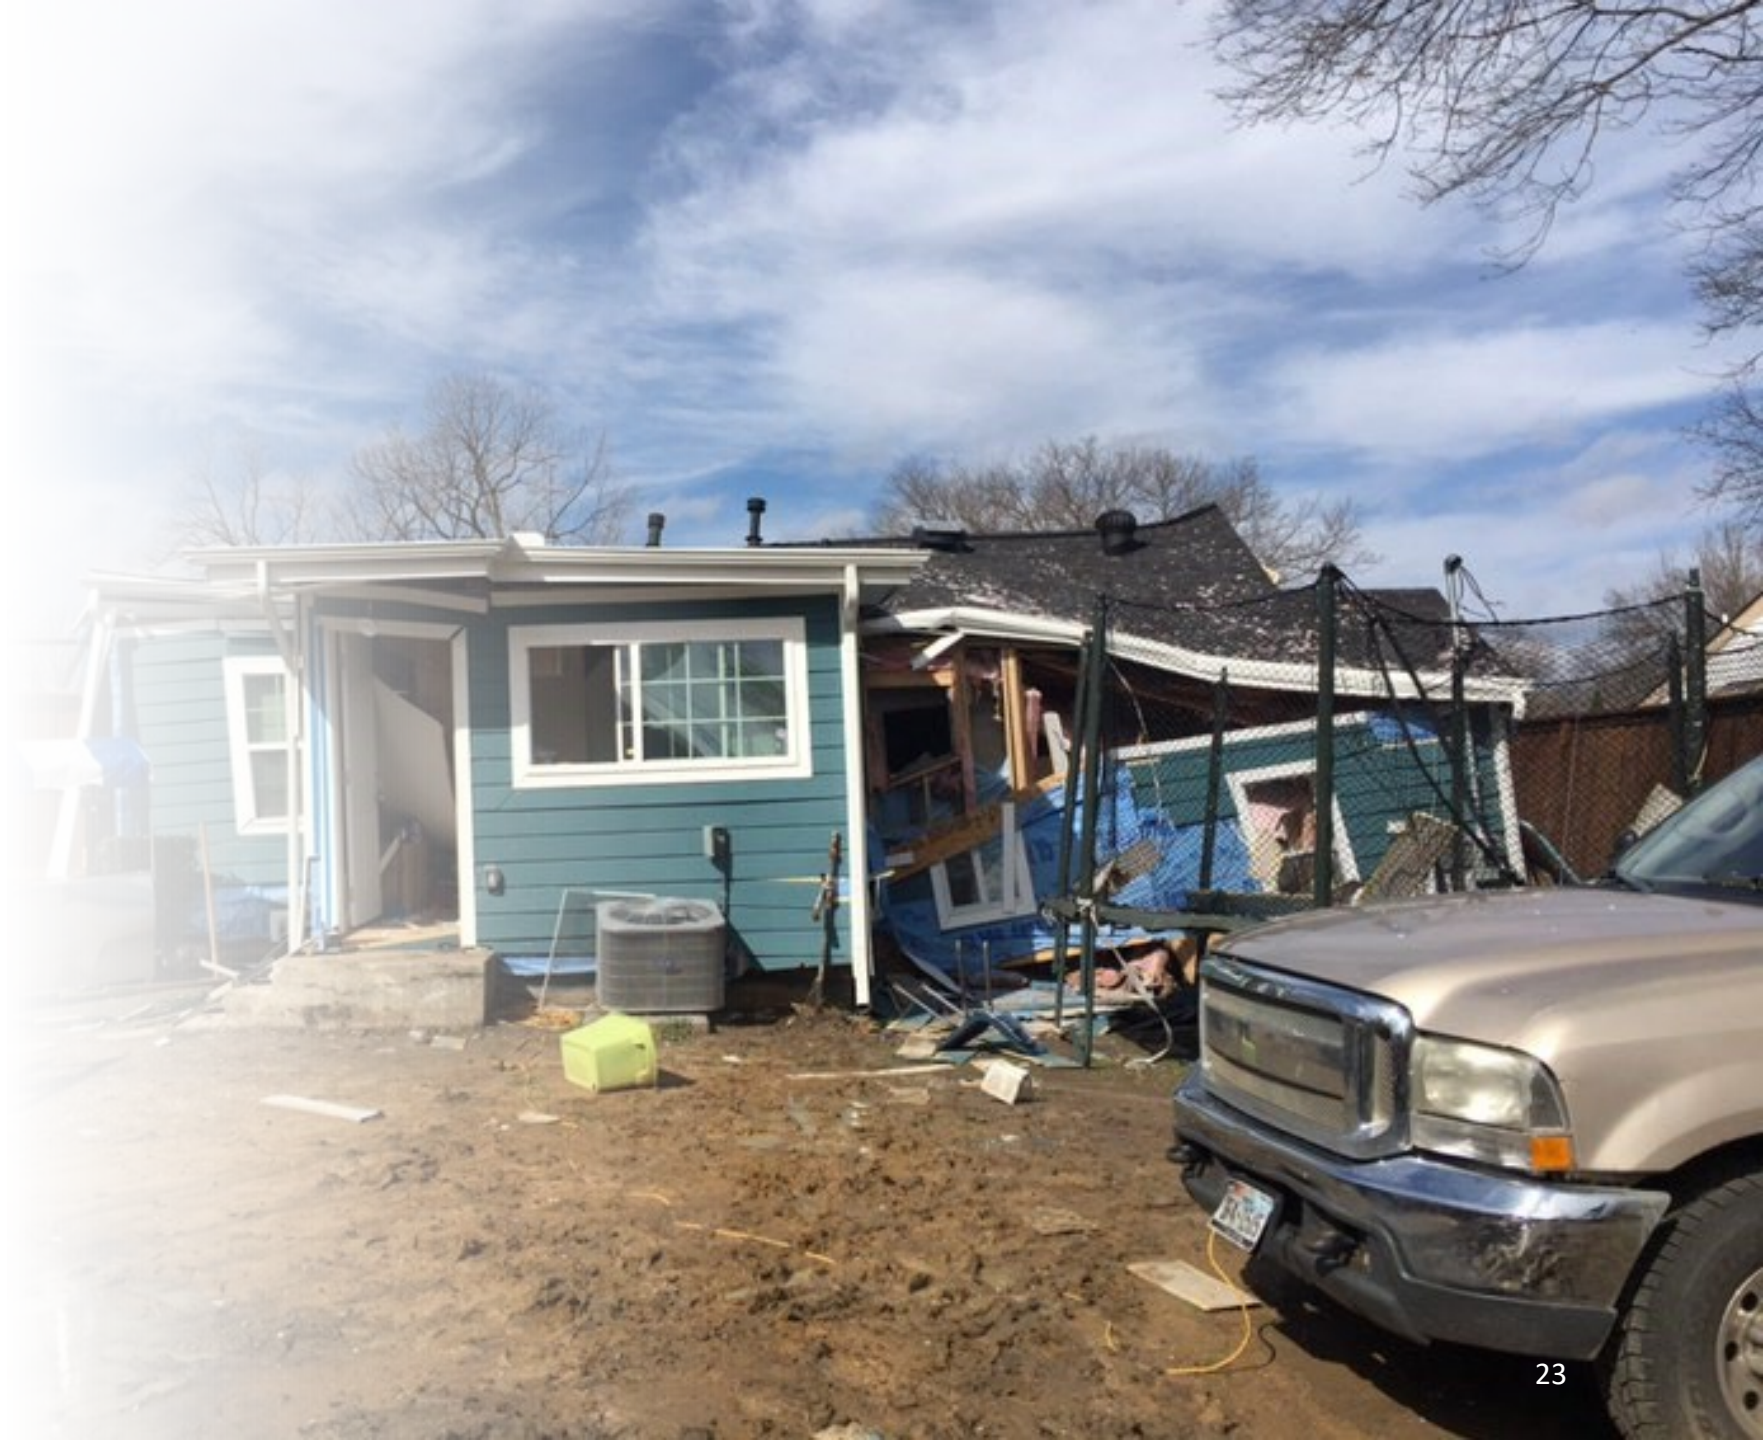
- February 23, 2018 – Day 3
- House 3534 has an incident at 6:38 a.m., with a fatality and 3 injured, 1 released
- Lived in home one month after full renovation. Including new gas and sewer service lines to alley.
- Homeowner heard a loud pop in kitchen around 11 p.m. but found no source.
- No gas smell prior to explosion
- TX-RRC, NTSB and PHMSA launched to investigate.

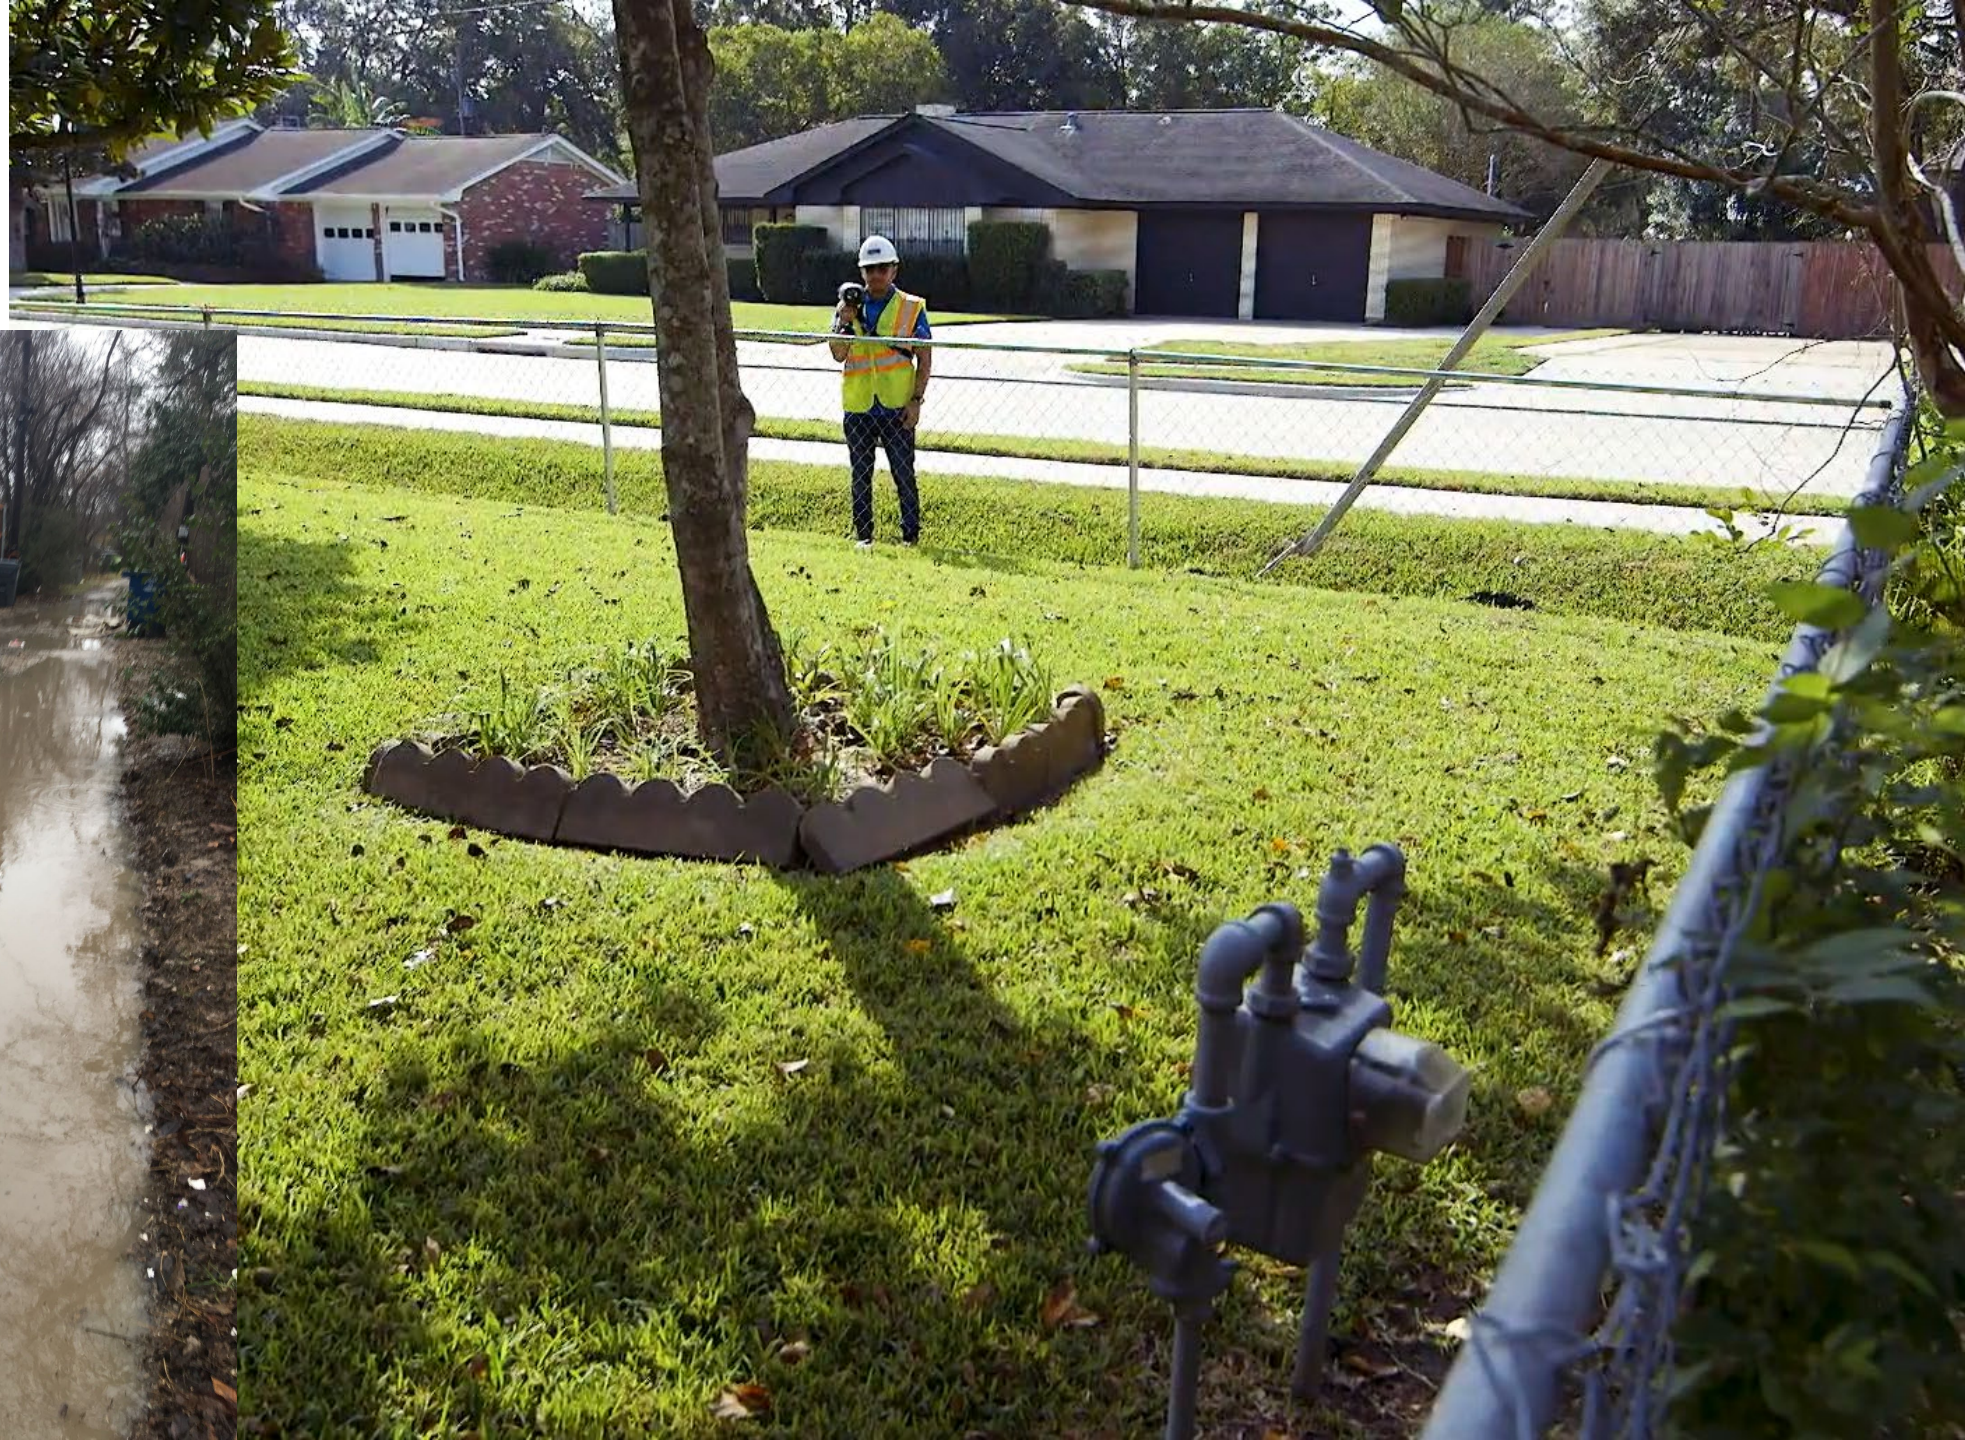
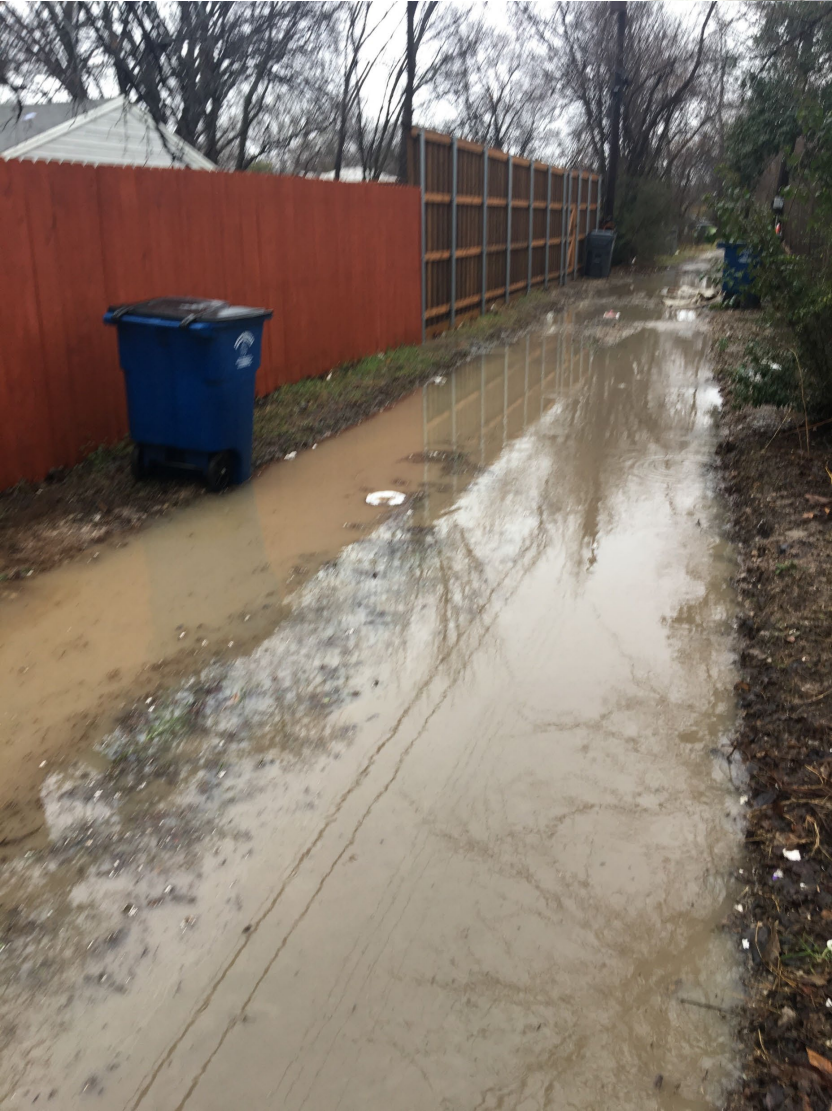
Leak surveys were performed after each explosion, with RMLD and CGI.

Pressure testing of mains and services with air will establish the integrity of the distribution piping, or not. Also, customer piping is often tested, but piping can be damaged during fires and explosions.

- Develop a pressure test protocol
 - Where to cut and cap main and services
 - Maximum test pressure and duration
 - If a leak is identified, then flow test to determine the size of the failure(s)
 - Large sections that fail test will need to be broken up

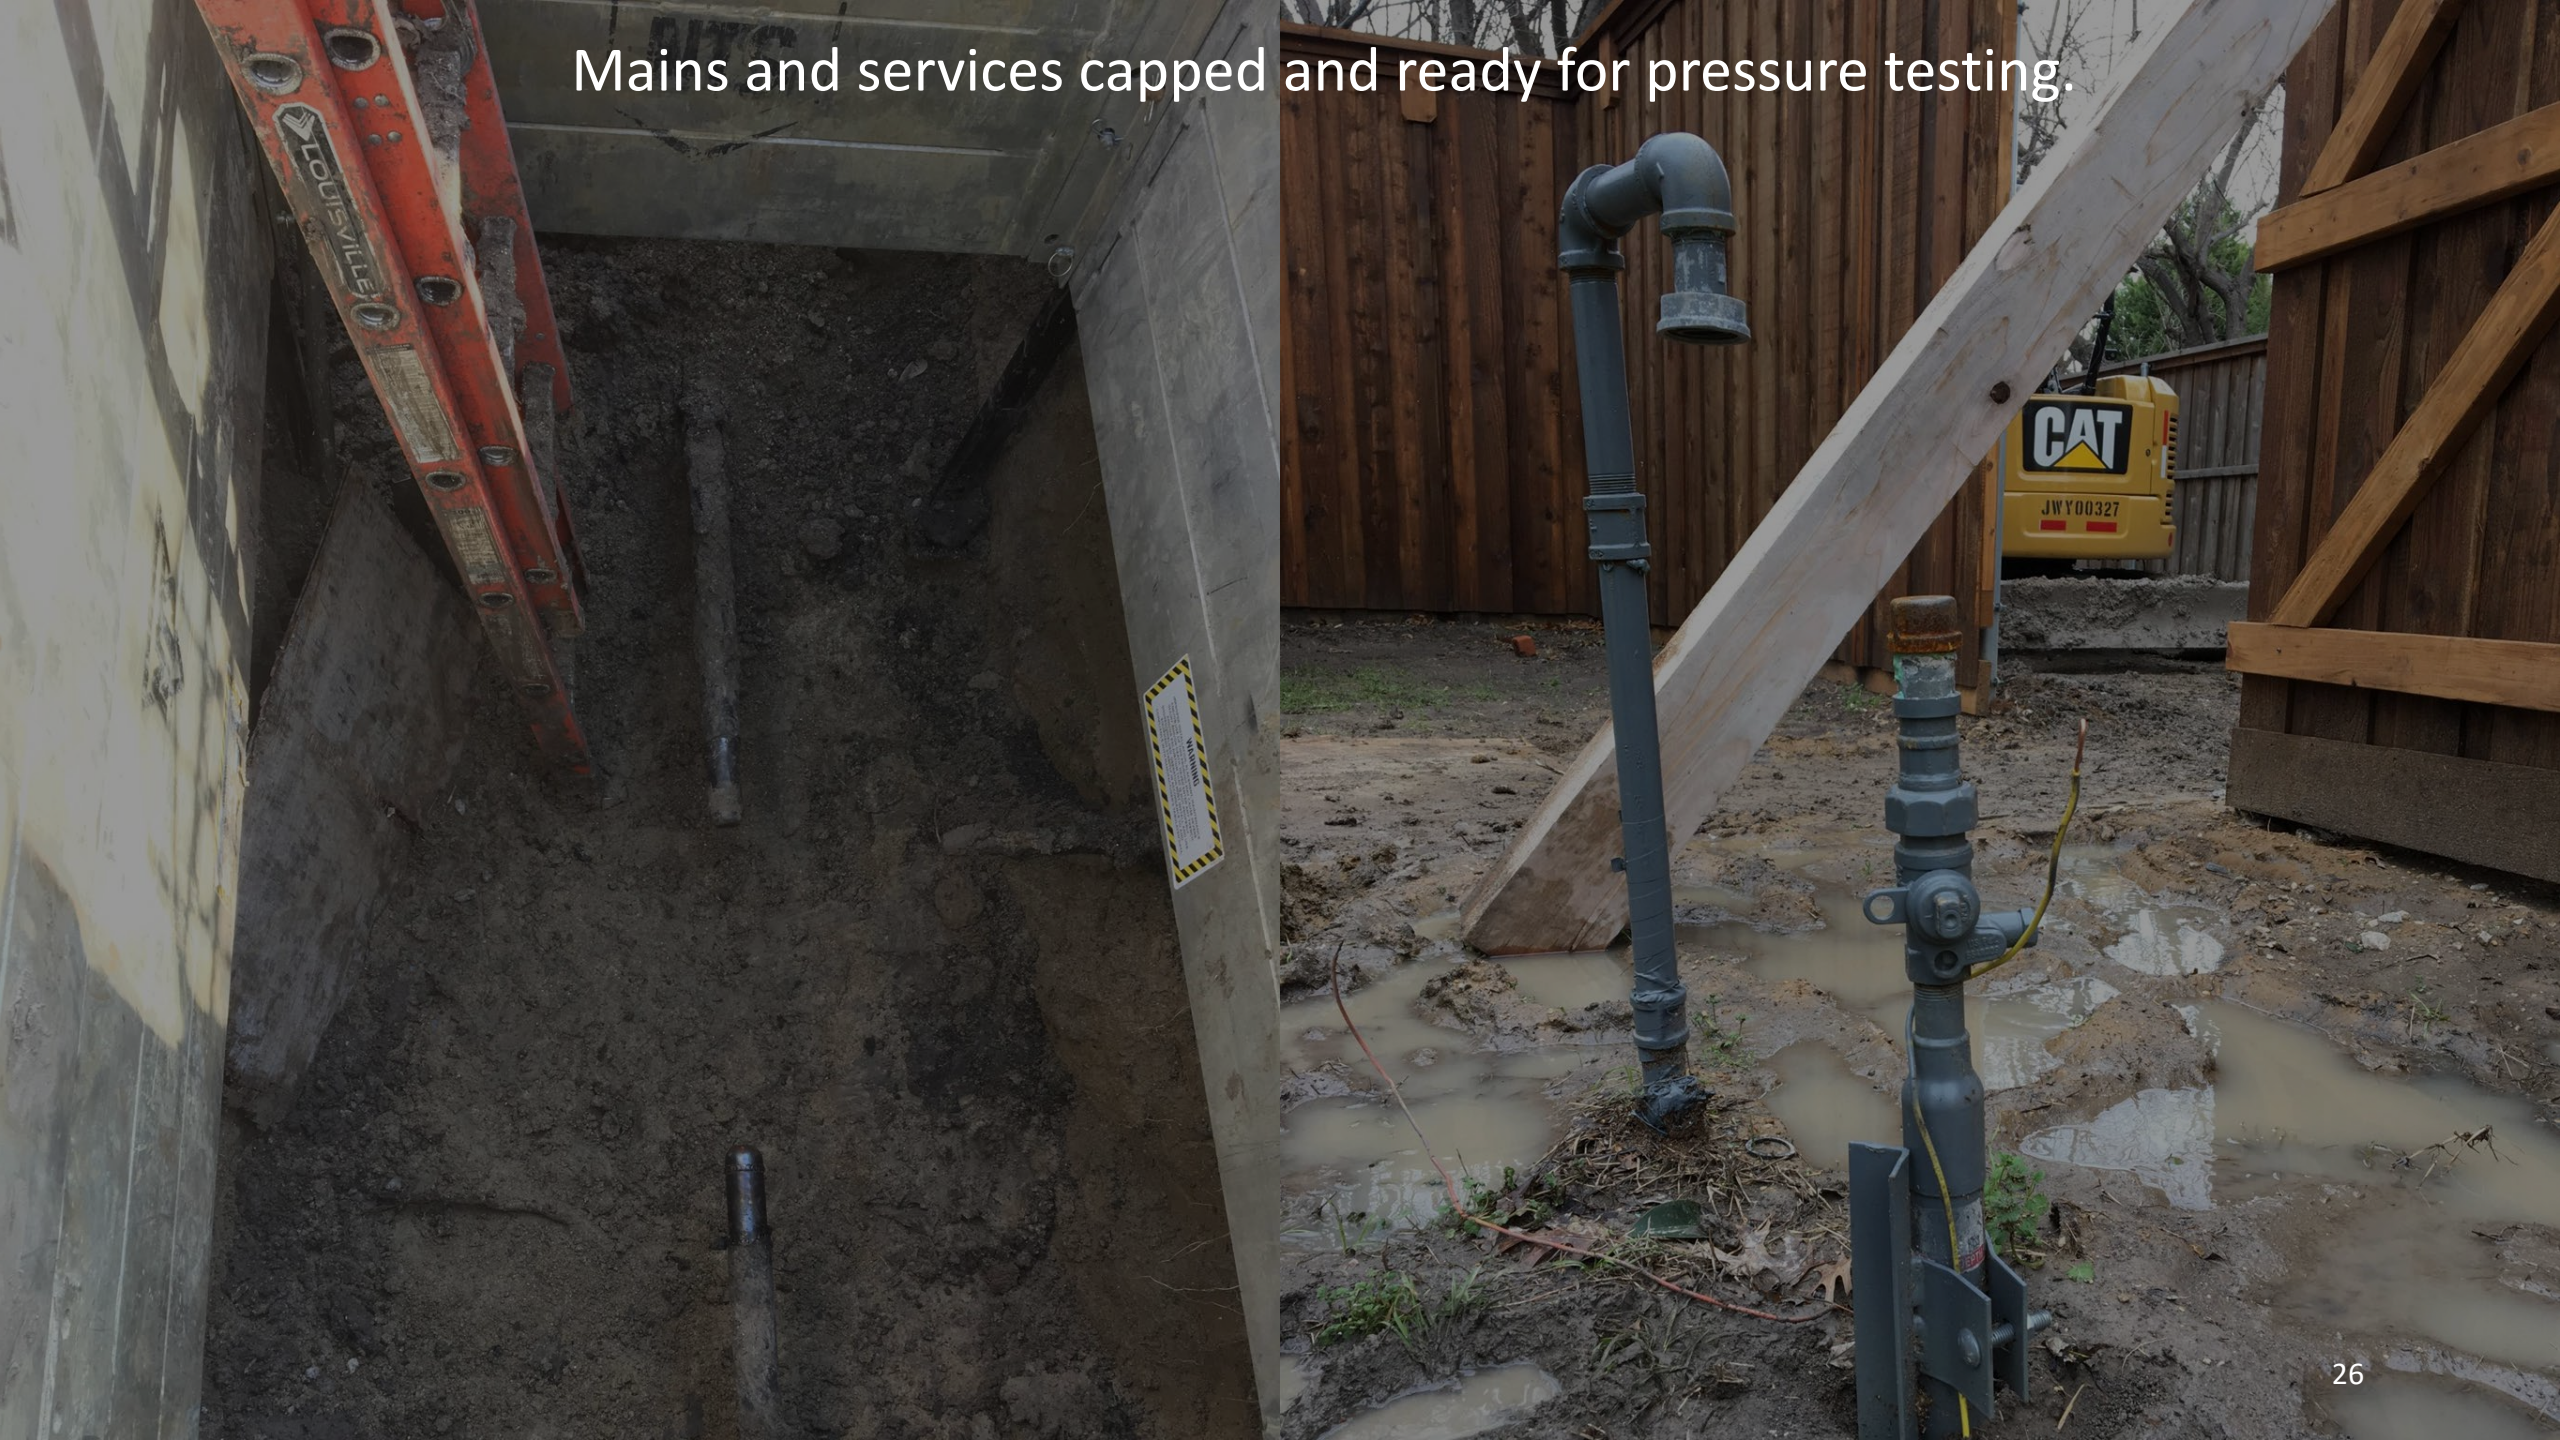
Mains and services capped and ready for pressure testing.
