Hard Spots

Advisory Bulletin (ADB-2024-01)
Identification and Evaluation of Potential
Hard Spots

U.S. Department of Transportation
Pipeline and Hazardous Materials
Safety Administration

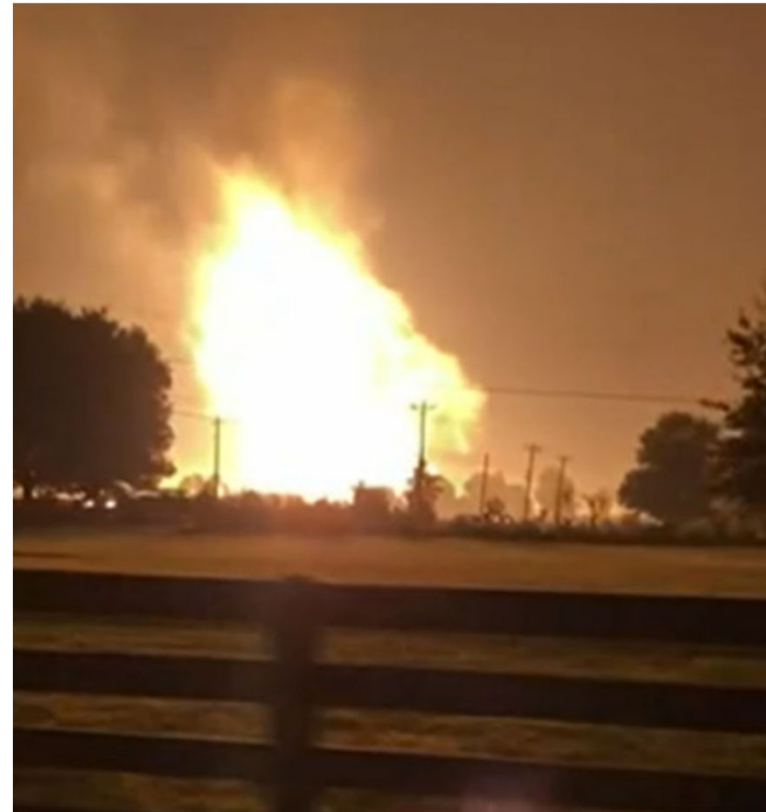
NTSB Investigation – Danville, Kentucky

National Transportation
Safety Board Investigation
Report Number PIR-22-02

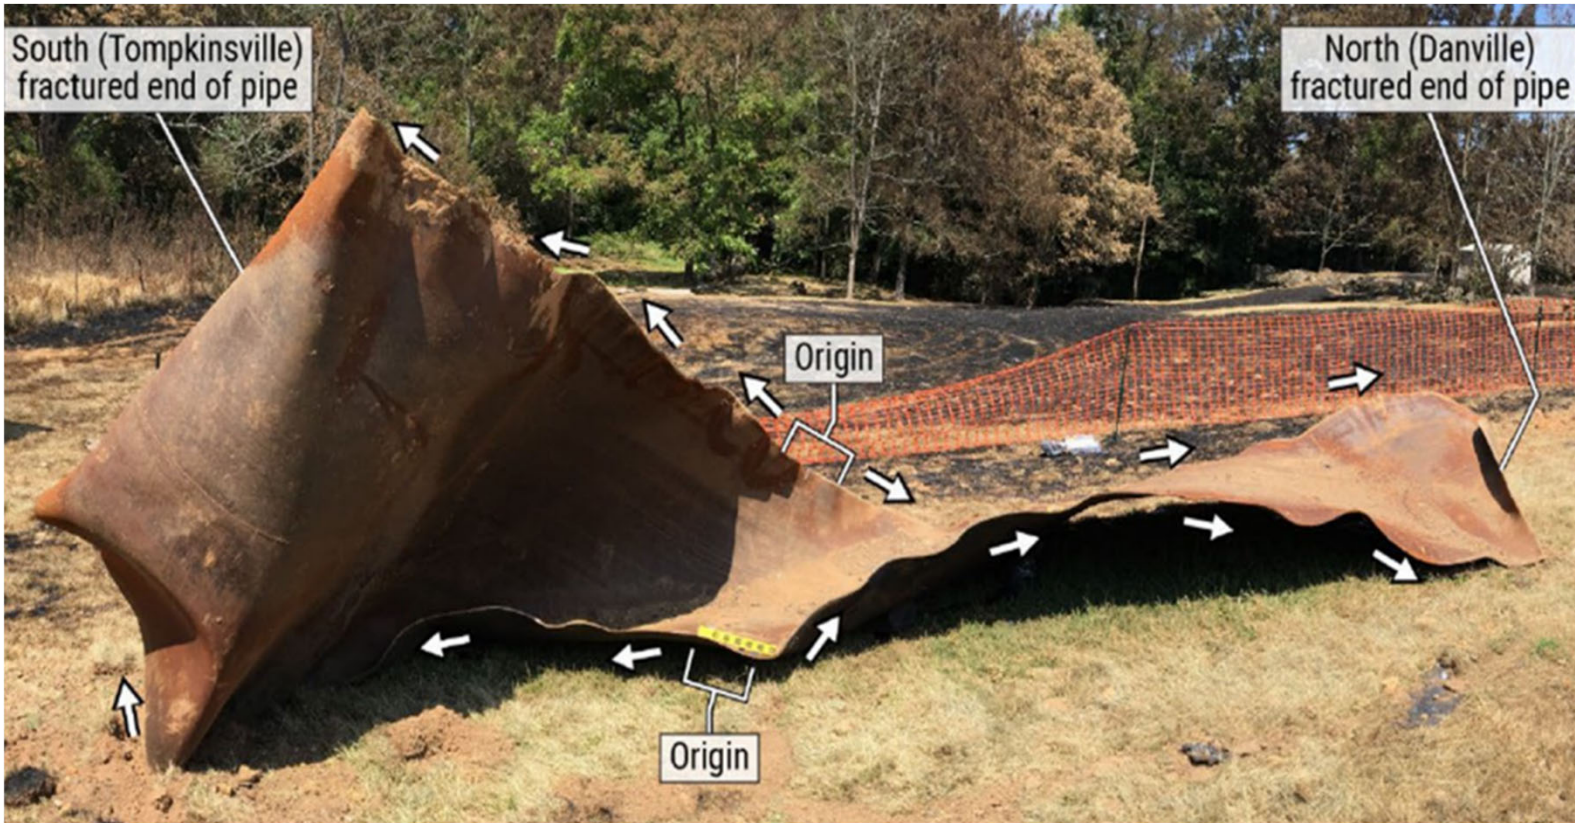
Danville Incident Investigation

- August 1, 2019
- 30-inch natural gas
- Danville, Kentucky
- 1957 - A.O. Smith
- Hydrogen-induced cracking in a hard spot – 5.85” x 3”
- Brinell hardness 362 – 381 extended through the pipe wall
- Operator ran ILI tools in 2004, 2005, and 2011
- Pipeline was cathodically protected with a coal tar coating
- Pipeline had a flow reversal in 2014

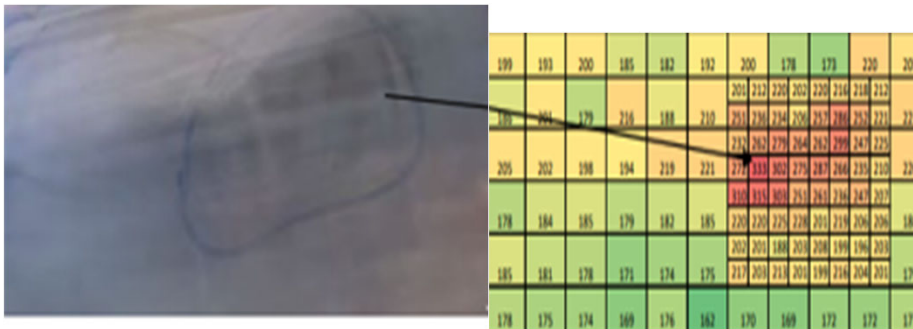
Hard Spot Integrity Program

- ✓ Locate ILI anomaly in the field
- ✓ Visual inspection (MPI)
- ✓ NDT technology
- ✓ Prep defect (polish/etch)
- ✓ Measure Hardness
