Ferebee Service Hill City South Dakota

Customer Service Description

Grounding Study

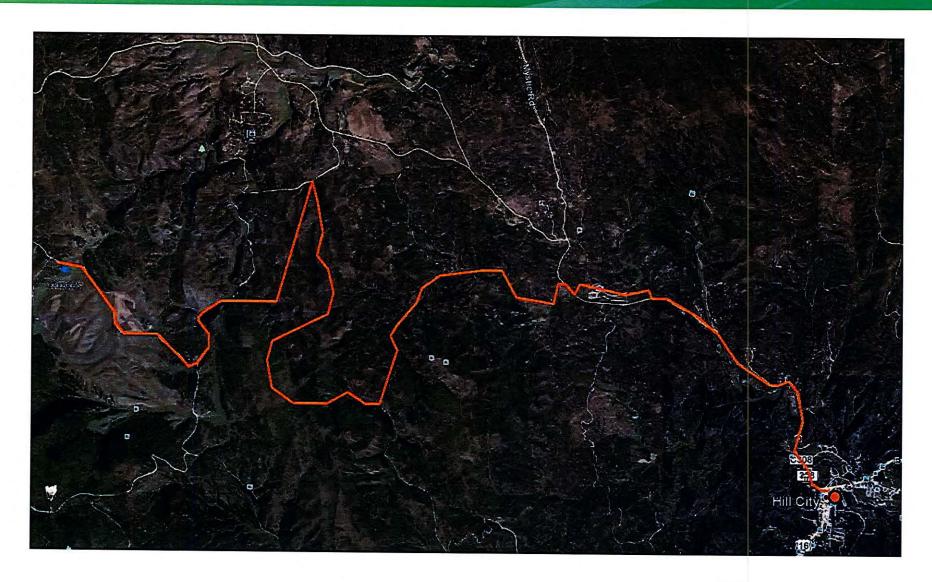
Cable Route / Map

- The Ferebee's are served digital carrier system which is 77,980 feet or 14.76 miles from the Hill City Central Office located at 205 Walnut St.
- There are four carrier systems on this cable route serving 241 customers today.
