Re: CPF 3-2015-5010; Notice of Proposed Violation, Proposed Civil Penalty, and Proposed Compliance Order issued to TC Oil Pipeline Operations Inc.

In the Matter of	)	
	)	
TC Oil Pipeline Operations Inc.,	)	CPF 3-2015-5010
	)	NOTICE OF PROBABLE VIOLATION
Respondent	)	
	)	**REQUEST FOR HEARING**

In the Matter of	
TC Oil Pipeline Operations Inc.,	CPF 3-2015-5010
	NOTICE OF PROBABLE VIOLATION
Respondent	
	STATEMENT OF ISSUES

2015 CIS Gap – KS9 MP 1078

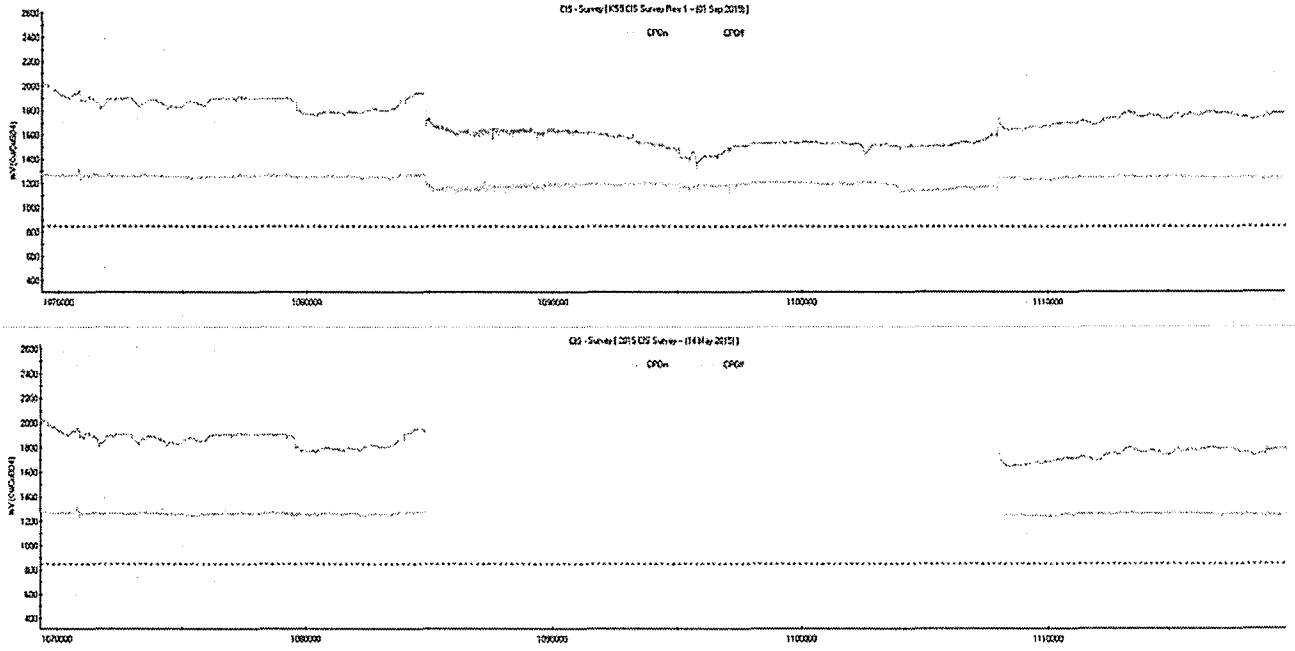
During the Closed Interval Survey (CIS) that was completed on Keystone in Q2 2015, an approximately 4 mile gap was present in the dataset along KS9 (Salisbury to Patoka) at approximately milepost 1078. This gap was located at the Carlyle State Fish and Wildlife Area, which was inaccessible at that time due to flooding. In late August when the water had receded to a manageable level to allow safe passage a crew returned to the site to obtain the remaining CIS potentials. As can be seen in the screenshot below, no below criteria CP measurements exist in CIS performed across the former gap.

Figure 1: 2015 CIS Datasets showing resolved gap
