## Pipeline Failure Investigation Report

**Pipeline System:** Distribution – service line      **Operator:** MDU  
**Operator ID:** 12684      **Unit Number:** \_\_\_\_\_      **Activity Number:** \_\_\_\_\_  
**Location:** Rapid City      **Date of Occurrence:** 2/10/2023  
**Material Released:** Natural Gas      **Quantity:** 22.0 MCF  
**PHMSA Arrival Time & Date:** NA      **Total Damages \$:** Estimated \$752,638  
**Investigation Responsibility:**     State     PHMSA     NTSB     Other \_\_\_\_\_

<i>Narrative Summary</i>
<p>Short summary of the Incident/Accident scenario</p> <p>On February 10, 2023, at 04:24 am, Montana Dakota Utilities (MDU) received a call reporting a house fire at 1414 Degeest Drive in Rapid City South Dakota. Upon arrival the MDU service technician determined a vehicle traveling in a residential subdivision left the roadway and struck an outside meter set on the house, shearing off the riser at ground level, causing a release of natural gas that ignited. The driver of the vehicle did not survive, and 4 residents of the house were transported to the hospital. The four residents of 1414 Degeest Dr were evacuated, occupants at 1426 Degeest Dr and 1392 Dege

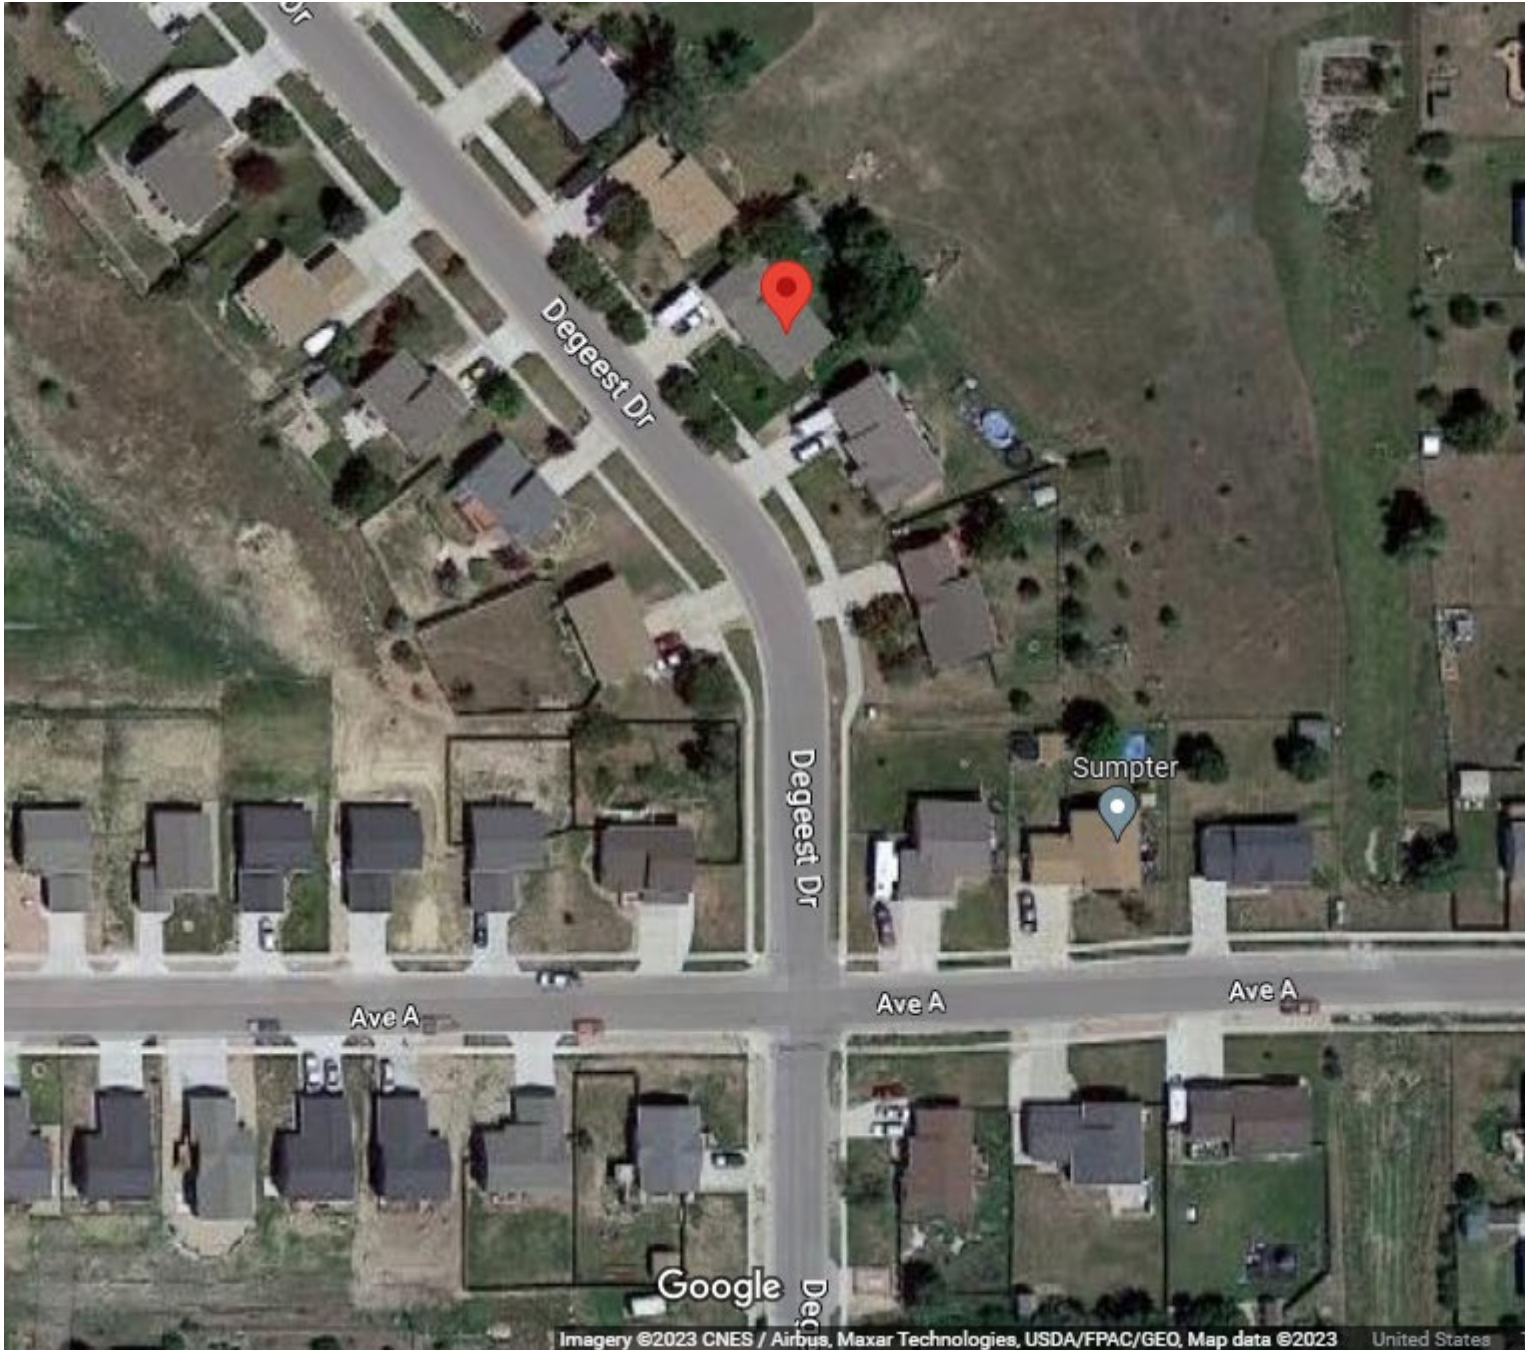
## Site Description

Provide a sketch of the area including distances from roads, houses, stress inducing factors, pipe configurations, etc. Bar Hole Test Survey Plot should be outlined with concentrations at test points. Photos should be taken from all angles with each photo documented. Additional areas may be needed in any area of this guideline.
