Waterbody Data Form

S302HA 001

Centerline ID: **07-02-2012 Prelim Q** Project Designated Name: **Keystone XL pipeline**

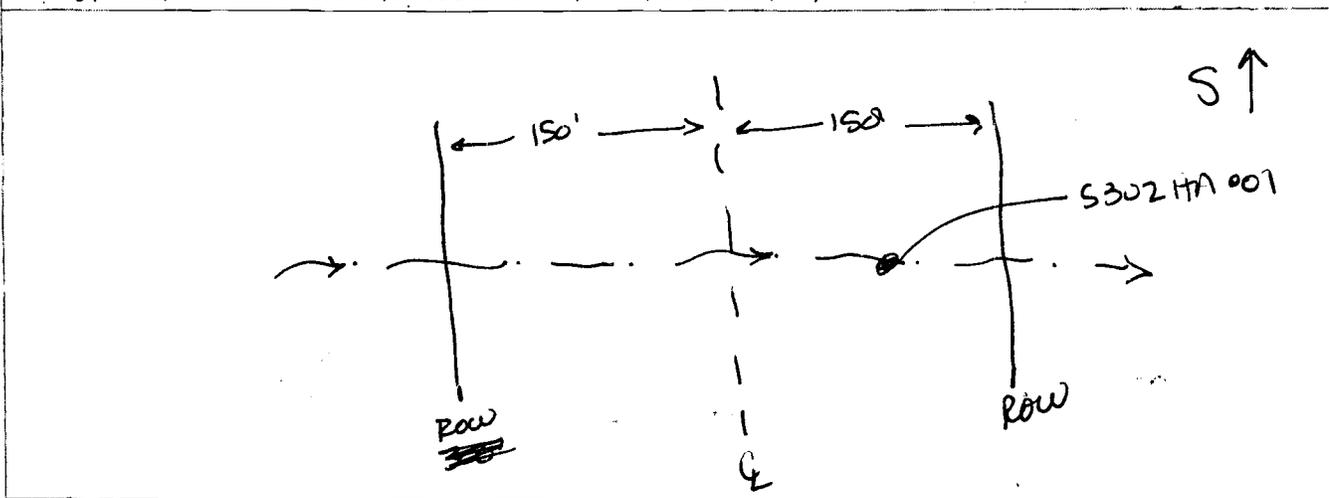
Drawing (Please provide orientation arrow, all features identified, location to centerline, etc.)

*1' deep
2' wide
1:1 banks*
