BEFORE THE PUBLIC UTILITIES COMMISSION OF THE STATE OF SOUTH DAKOTA

)
IN THE MATTER OF THE PETITION OF) Docket 14-001
TransCanada KEYSTONE PIPELINE, LP FOR)
ORDER ACCEPTING CERTIFICATION OF) DAKOTA RURAL ACTION'S POST-
PERMIT ISSUED IN DOCKET HP09-001 TO) HEARING BRIEF
CONSTRUCT THE KEYSTONE XL PIPELINE)
)

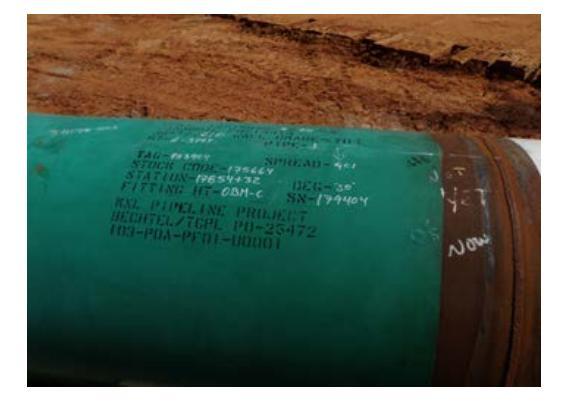
Figure 1: Pipe Specification Markings

During the field inspections, the pipeline was verified for design specifications by examining the pipe for manufacturer stamping and reviewing manufacturer test reports (MTRs). Each pipe joint was marked with length, grade, pipe size, and specification. See Figures 1 and 2 for examples.

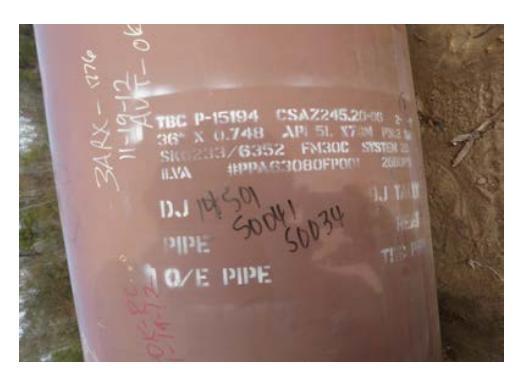
Figure 3: ARO Pipe with specification markings.

Pipe used for the construction had different wall thicknesses for different application locations such as: 0.465" for line pipe, 0.515" for HCAs, 0.572" downstream of pump station, 0.618" for road bores, and 0.748" for HDDs. HDD and road bore pipe also had abrasion resistant overcoat (ARO) which was verified during the field inspections as seen in Figure 3. Pipe joints were marked with the appropriate specifications, for example, API 5L

PSL2 36", 0.465", X70.

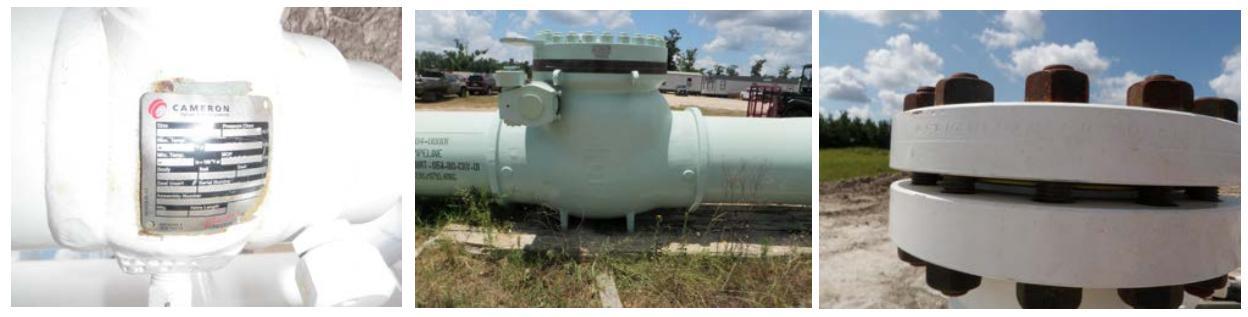
Figures 4, 5, 6: Manufacturer Stamp on Valve, and Flange

Valves and other pipeline components were also verified in the field. Valves were manufactured in accordance with API 6D and were stamped with manufacturer's name, maximum pressure rating, temperature rating, nominal size and body material. Fittings were

examined for damage such as buckles, dents, gouges, cracks or other defects that might reduce the strength. Pipe joints were tracked by a labeling system with a bar code. See Figures 4-6.

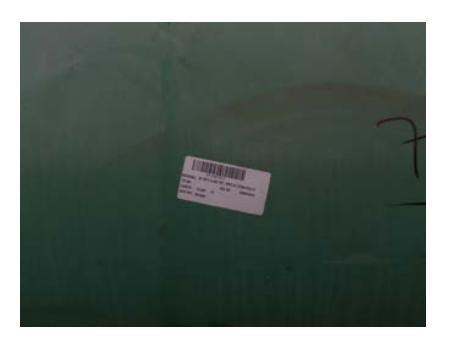
Figure 7: Pipe Label

Labels were checked in the field for damage or nonreadable labels. See Figure 7. All components inspected were consistent with the pressure rating and in accordance with the established MOP.

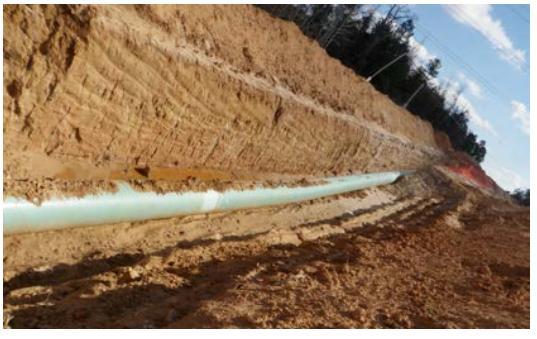
Figure 8: Typical Right of Way depicting Depth of Cover.

During the field inspections, PHMSA inspected the pipeline ROW for any private dwellings, industrial buildings, and places of assembly. The ROW of the pipeline avoided and was not in close proximity to any of these structures or locations. The inspection of soil cover and depth of pipe was in compliance with the regulations. The pipeline had a cover of at least the minimum cover required at all locations inspected during the field inspections. Figure 8 shows the depth of the pipe. The Figure demonstrates the cover and depth of the pipeline and the remoteness of the pipeline ROW. Figure 9 shows the depth of pipeline is verified with a GPS system.

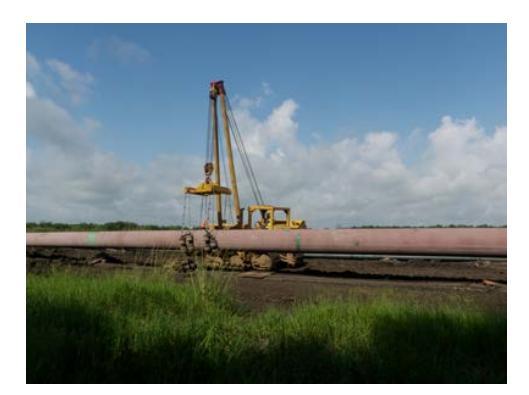
Figure 10: Boom holding Pipe

To avoid many road and railroad crossings, other pipeline, bodies of water and any other encroachments, TransCanada horizontally directional drilled (HDD) the pipeline at these locations. The depth of the HDDs well exceeded the depth of cover required by the regulations. PHMSA witnessed and inspected HDD construction activities for any issues and to assure specifications were followed. The Figures demonstrate the inspection of the HDDs. Figure 10 shows pipe is being supported

by a boom as it is being pulled into the drill.

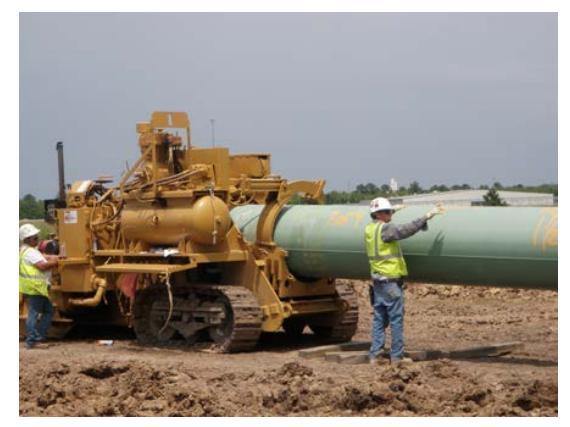
Figure 11: Bending Machine

Field pipe bends were observed by PHMSA during many field inspections. There were no wrinkle bends identified during these inspections. Pipe bends were performed by a bending machine which utilized an internal bending mandrel to achieve smooth and undistorted bends. PHMSA witnessed pipe bending activities which are shown in Figures 11 and 12. There was no mechanical damage identified during the pipe bending activities.

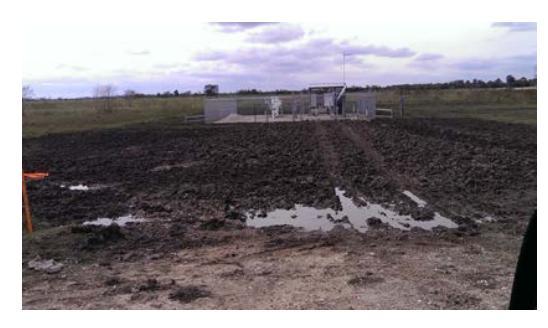
Figure 13: Typical Valve location

Valve locations and automation equipment were verified during the field inspections by PHMSA.

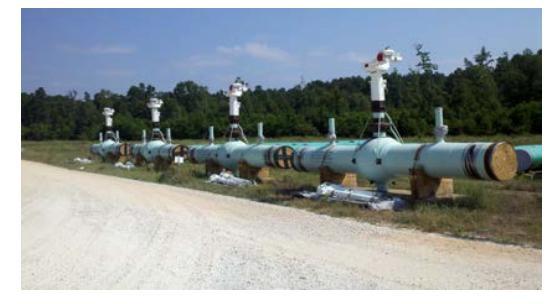
Figure 15: Valve Storage at Pipe Yard

Valves were inspected at the pipe yard on several occasions to verify the rating and condition of the valves. Figure 15 shows valves inspected at the pipe yard. Valves were stored away from the pipe to protect from any damage.

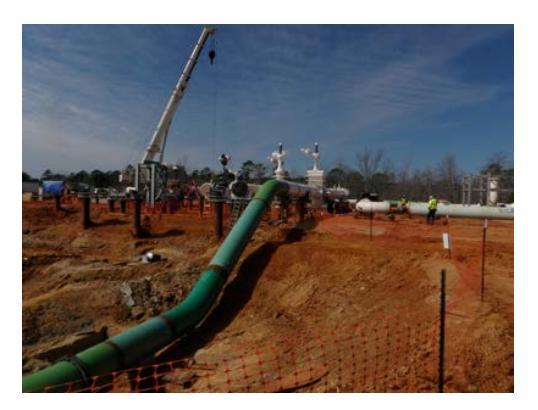
Figure 16: Valve at Pump Station

There were also valves located at each discharge and suction side of the pump stations. Figure 16 depicts an example of a pump station valve installation.

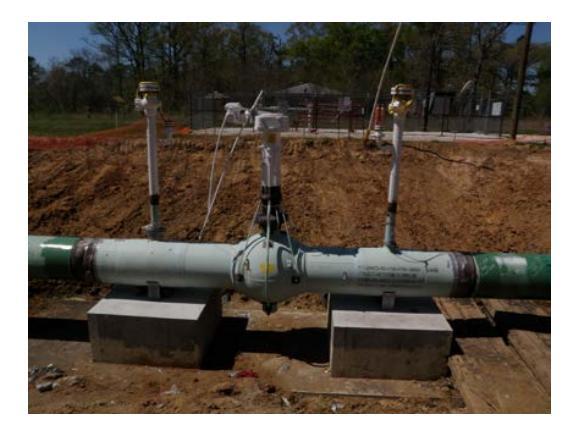
Figure 17: Concrete Pads for Valves.

All valves are motorized and remotely operational through SCADA. All valves had concrete foundation poured to handle any stresses the weight may put on the pipeline. Figure 17 is an example of concrete supports. Figure 18 demonstrates the protection from unauthorized personnel and vandalism. In addition, the photos show the satellite, electric power and generators for backup needed to operate the valves.

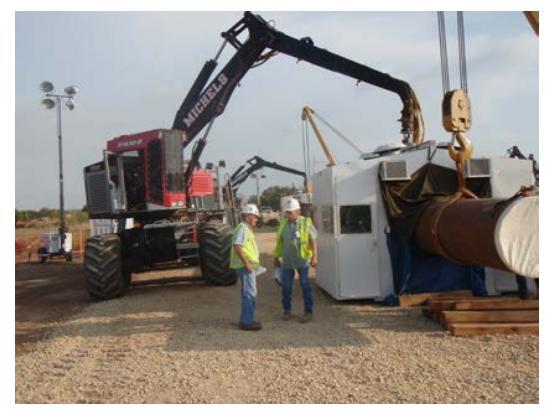
Figure20: Automatic Welding Shack

Welding was performed in accordance with API 1104, the federal regulations and TransCanada's specifications. TransCanada utilized automatic welding on spreads 1 and 2 and manual welding on Spread 3. Both automatic and manual welding was being performed while PHMSA was on site.

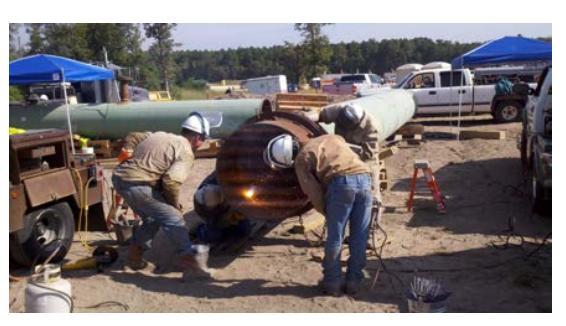
Figure 19: Welder Qualification Test

Throughout the construction project, PHMSA reviewed welding procedures, specifications and conducted field observations of welding activities. In addition, PHMSA witnessed the qualification of procedures and welders to assure welding was being performed to a qualified procedure and by qualified welders.

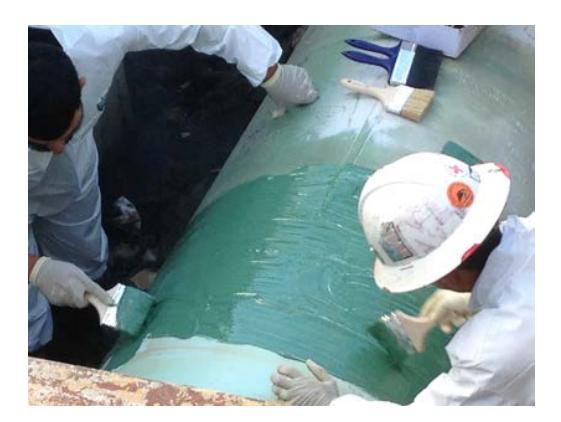
Figure 23: Coating of field Joint

During the field inspections by PHMSA, the installation of corrosion control measures was verified. TransCanada provided corrosion control specifications which were reviewed by PHMSA. PHMSA witnessed the installation of many joints of pipe to assure that the coating was in good condition and was inspected (jeeped) for coating damage before burying the pipe. Any damage identified by this inspection technique was repaired. Each weld joint was coated and is seen in Figure 23. PHMSA also verified that there were a sufficient number of test leads installed throughout the pipeline.

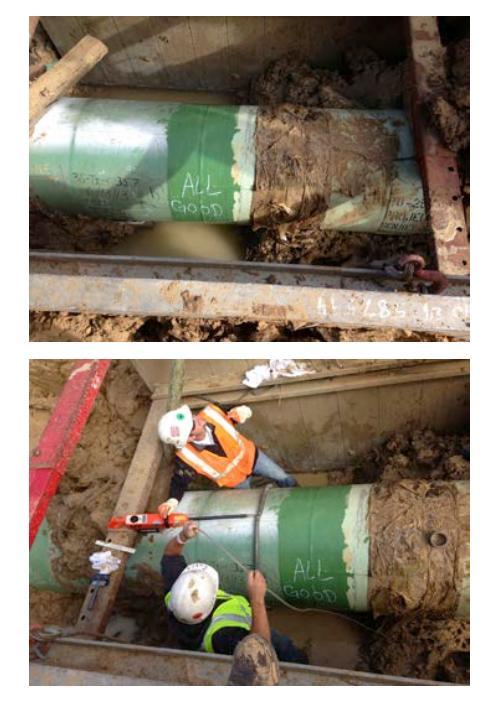
Figure 25 and 26: DCVG dig site (recoated)

TransCanada conducted a Direct Current Voltage Gradient (DCVG) survey of the entire Keystone Gulf Coast Pipeline to check for any coating damage. After the survey, TransCanada submitted the findings of any coating damage found along with repairs made on anomalies. There were a total of 127 anomalies on Spread 1, 83 anomalies on Spread 2, and 43 anomalies on Spread 3 found by the survey. None of the anomalies found met the repair criteria of 35% IR, the highest was 32%. TransCanada performed verification digs on the highest IR readings on all three spreads to assure accuracy of the DCVG Survey. They made 8 digs in Spread 1, 8 digs in Spread 2, and 4 digs in Spread 3 and made repairs accordingly. The reports were reviewed by PHMSA to assure compliance with their procedures and the regulations. PHMSA conducted field inspections to verify dig sites identified by the DCVG survey. Figures 25 and 26 depict two locations identified by the DCVG survey during a PHMSA field inspection.

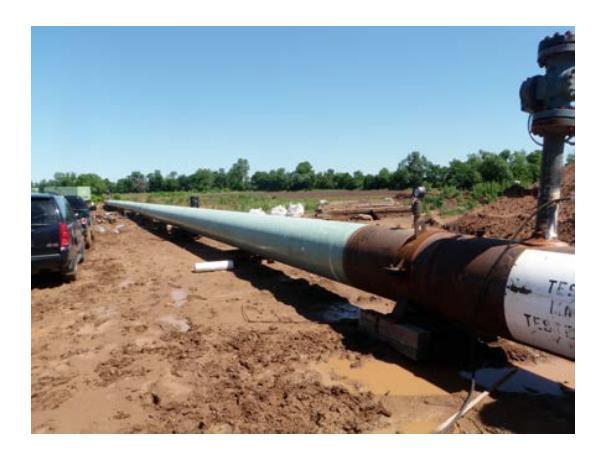
Figure 27: Hydrotest in Progress

Pressure testing of the TransCanada was performed in accordance with their Specification TES-PROJ-LPCS-US and with CFR 195. The specification and records of all hydrostatic pressure tests conducted by TransCanada were reviewed by PHMSA. In addition, PHMSA conducted field inspections of the hydrostatic testing on various locations of the pipeline.

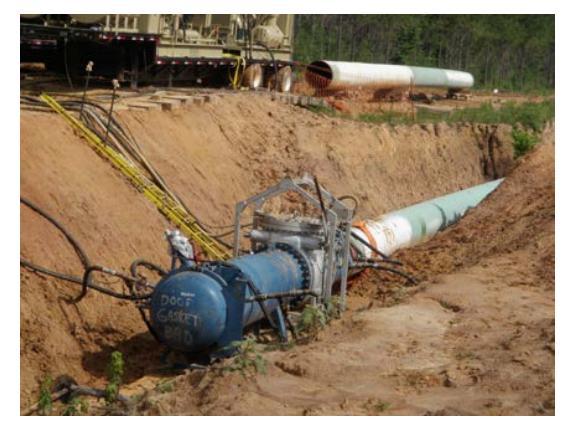
Figure 29: Drying process after hydrotest

The entire pipeline was hydrotested to at least 8 hours for all buried pipelines. In addition, TransCanada conducted a one hour pressure test on all HDD piping before pulling the pipe section. The one hour test is part of TransCanada's procedures to verify the integrity of the HDD pipe before pulling it through the drilled hole. The test medium used for all testing was water. All records reviewed had documented the appropriate pressure of 125% or more of MOP, test medium, instrument calibration, pressure recording charts, temperature, date and time and description of the facility being tested. TransCanada also provided elevation profiles of all test sections with hydraulic pressure profiles. There were no leaks or failures detected in the records review and during the field inspections.

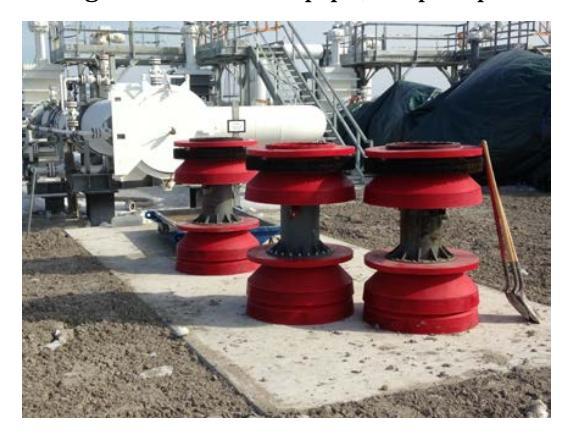
Figure 30: Pigs used during commissioning.

stations and the Nederland Delivery Station. Product was tracked utilizing three batch pigs to assure the location of the product. Each pig was tracked by Corrpro personnel and predetermined above ground markers (AGM). During the commissioning phase, each mainline valve was operated to assure no leaks and satisfactory operation of the valve. In addition each pump station was started up in stages. Each stage consisted of testing each leak detection system and alarms per pump before

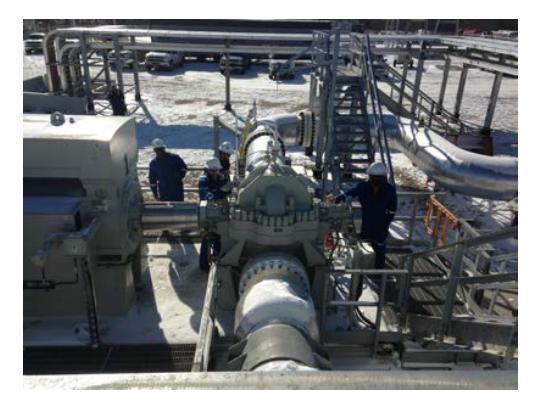
Figure 31: Commissioning at Pump Station

PHMSA received daily updates throughout the commissioning phase of all ongoing activities. In addition, PHMSA engineers/inspectors were onsite during the commissioning phase to witness and assure procedures were being followed by TransCanada personnel. PHMSA witnessed the line fill, testing of pump alarms and leak detection, valve testing and pig tracking operations. The Figures demonstrate the observations of the activities witnessed during the commissioning. The Figure 43 shows the pigs used to track the product while filling line. Figure 44 shows how the pigs were tracked from above ground.

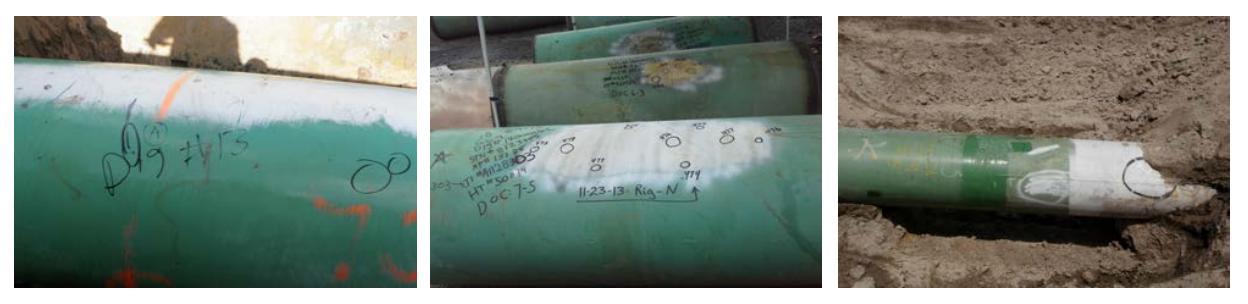
Figure 32, 33, 34 Examples of dents found with inspection tool.

TransCanada did not assure that its Keystone Pipeline was installed in the ditch in a manner that minimizes the possibility of damage to the pipe. The deformation tool identified dents on the pipe that appear to be caused by secondary stresses on the pipe. The ILI tool identified a total of 421 anomalies which required investigation per the specifications. There were a total of 236 dents, 56 pipe ovality and 129 anomalies with both dent and ovality. TransCanada verified the locations by excavating the anomalies and made repairs in accordance with their specifications. After excavating and examining the anomalies, there were a total of 350 anomalies within the specifications, 37 anomalies which required being cut-out and 34 anomalies with no indications of a dent or ovality. During the field inspections, PHMSA witnessed and examined anomaly investigations being conducted by TransCanada due to the results of the deformation tool run. In this report you can see examples of the types of dents identified with the inspection tools. Each dent was examined

and measured and nondestructively tested with ultrasound testing equipment to check for cracks. All dents were either cutout or were below the repair criteria. Several anomaly reports stated that foam pillows and rocky terrain were present at the dig sites which may

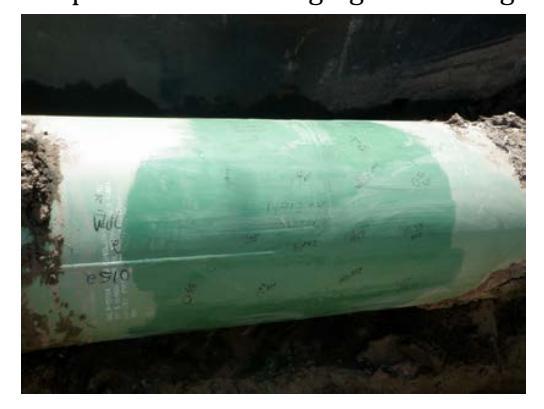
Figure 35: Repair of coating due to weld splatter.

During the field inspections, PHMSA observed several girth welds had coating damage due to weld splatter. Figure 35 shows the coating repair on the girth welds due to damage of the weld

splatter. The coating repair was made after the pipeline was exposed and examined. The pipe was coated and backfilled per the specifications. There were a total of 130 identified locations excavated in which TransCanada examined for damage and made repairs were necessary. All discovered damage was inspected and repaired to original specification criteria.
