# NORTH DAKOTA GAS PIPELINE SAFETY PROGRAM

2012 Summary

## Minot, ND Incident Summary

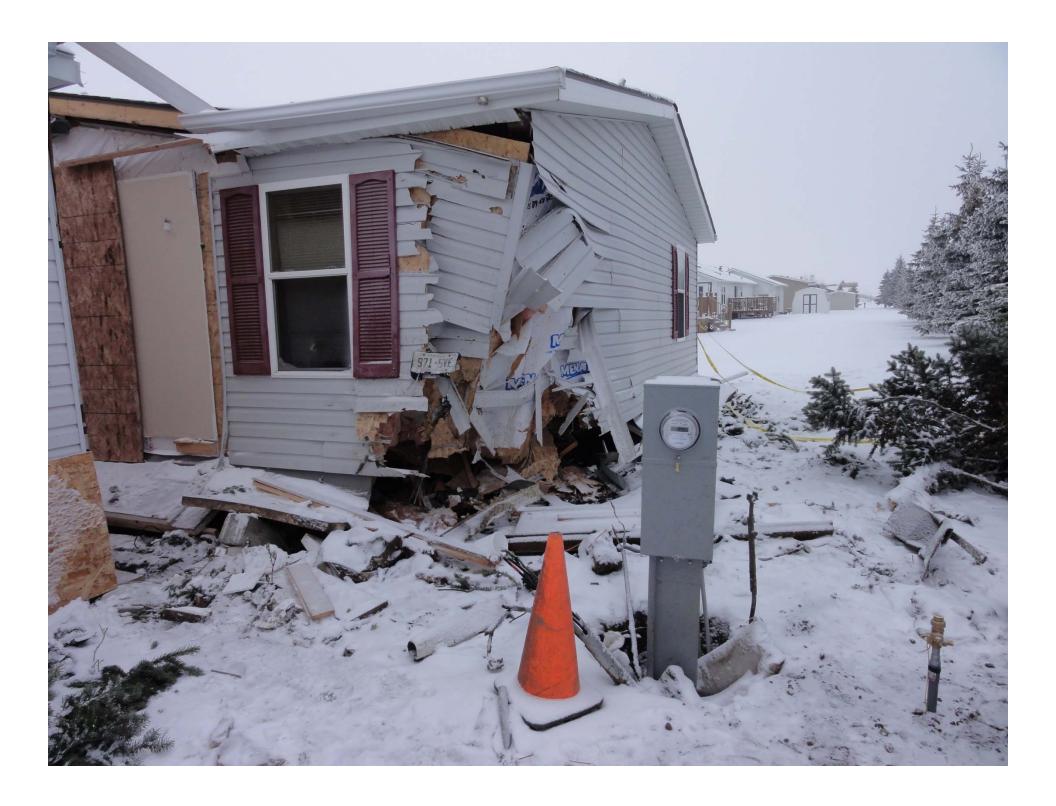
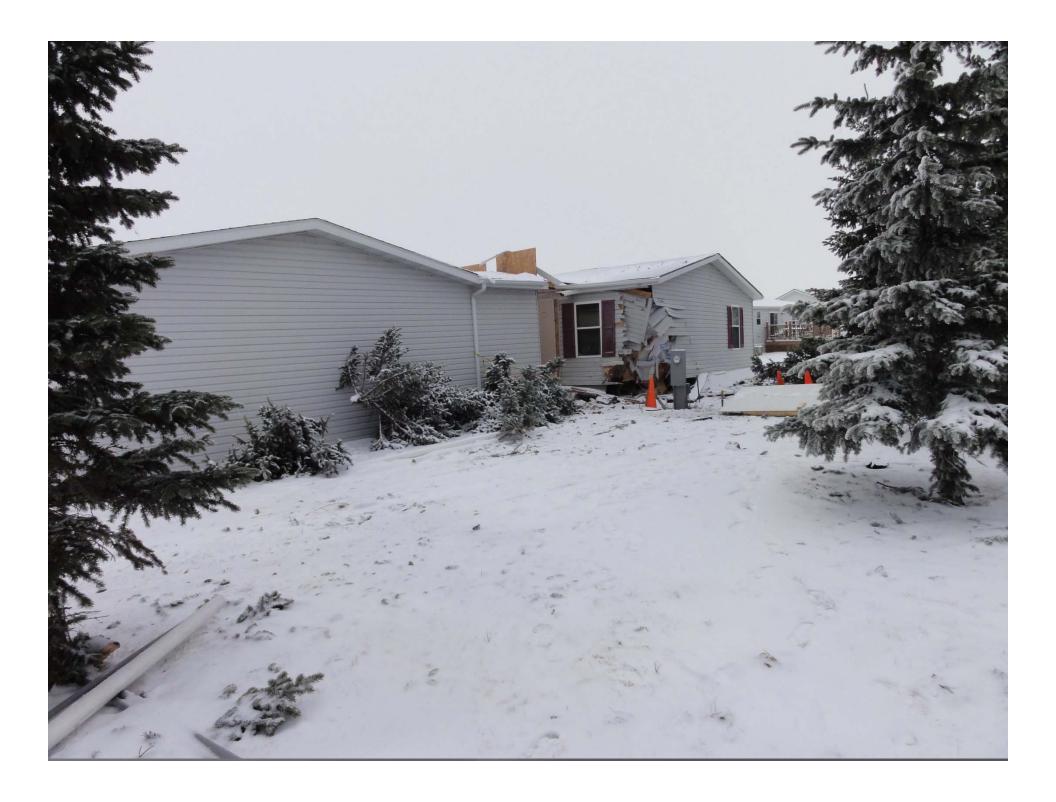
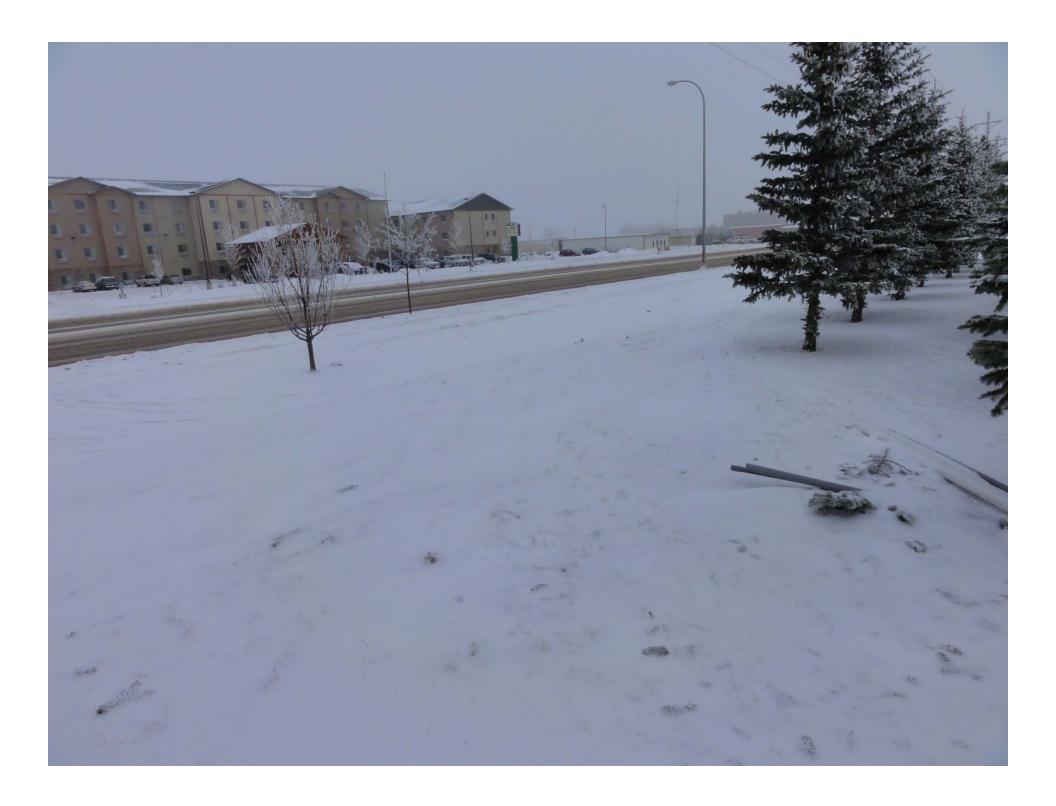
- 14:34 CST on December 8, 2012.
- A 1 ton truck heading West on 37<sup>th</sup> Ave, left the roadway crossing traffic, jumped the curb, went through a row of trees and collided with a private residence.
- Emergency responders, the fire department, shut off the gas supply at the meter stop valve shortly after arriving.
- The meter set was sheared off by the vehicle impact.
- The driver was taken to the hospital, checked and released. 1 person evacuated from home.
- Property damages including the damaged house, vehicle, operator meter set and riser totaled about \$120,000.00.

Root cause of the incident was an uncontrolled vehicle striking a
meter set alongside a house that was also struck and damaged. The
unusual nature of the collision and resulting gas release was not
because of any problem or defect of the meter set and riser, but
because of an unusual, random type of accident.

The root cause of the incident is attributable to the privately owned vehicle and not the operator. The operator's meter set was situated in a location where extra vehicular barricading was not necessary as it was in a no traffic area.

This is an extremely rare and isolated incident and no changes in standards or practices are needed for their meter set protection.

In agreement with this conclusion but in the extremely rare chance that a similar incident such as this would occur, further review or recommendations would then be considered.
